**Flood Control Project Maintenance
Levee Inspections**

Fall 2011 Levee Maintenance Deficiency Summary Report

**Flood Control Project Maintenance
Levee Inspections****LMA District Cover Sheet
Fall 2011 Levee Inspection Results****Butte County Public Works**

Levee Inspection Report By Mile - Fall 2011

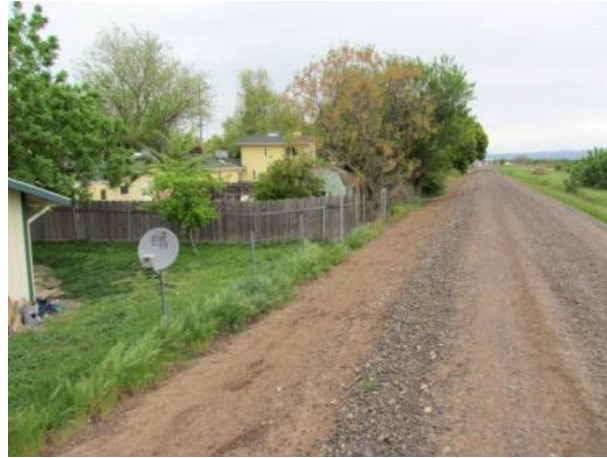
| Levee Mile Report Line | 1 |

| Waterway | | | | | | | Bank | Unit Miles | Inspection Start/End | Inspector |
|---|---|---|---|---|---|---|---|---|---|---|
| 1 | 2.06 | 2.10 | Earthen Levee | Encroachments | LS | CO | Fences | 39.748330 ° -121.918685 ° | 39.748867 ° -121.918533 ° | 3 Y |

View of the fences along the L/S toe.

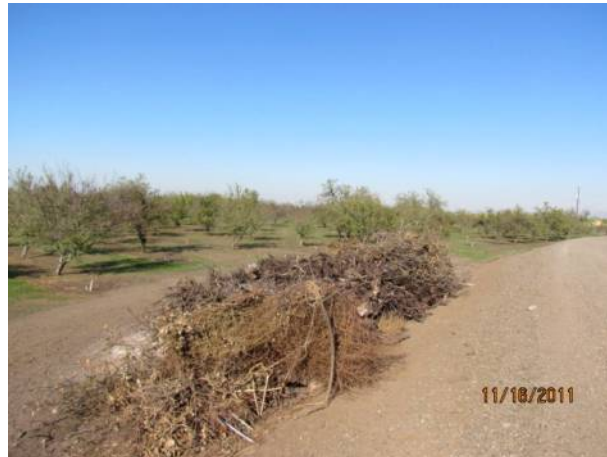
| Levee Mile Report Line | 4 |

| Waterway | | | | | | | Bank | Unit Miles | Inspection Start/End | Inspector |
|---|---|---|---|---|---|---|---|---|---|---|
| 4 | 2.65 | 2.65 | Earthen Levee | Encroachments | LS | M | Prunings | 39.755897 ° -121.914808 ° | 39.755897 ° -121.914808 ° | 2 Y |

View of the prunings pile.

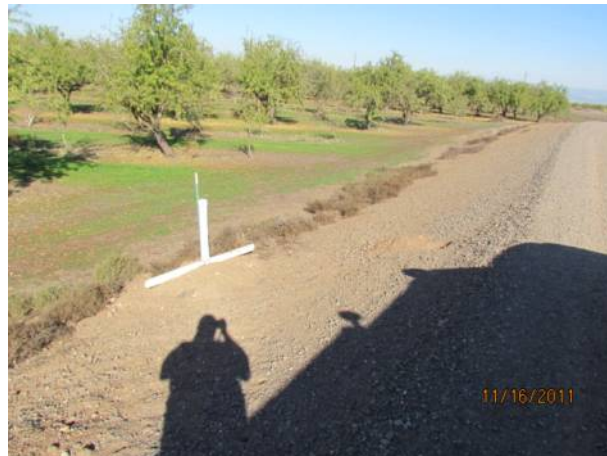
| Levee Mile Report Line | 5 |

| Waterway | | | | | | | Bank | Unit Miles | Inspection Start/End | Inspector |
|---|---|---|---|---|---|---|---|---|---|---|
| 5 | 2.90 | 2.90 | Earthen Levee | Animal Control | LS | M | No rodents visible, but rodent burrows visible; need to backfill and compact or grout burrows. | 39.758788 ° -121.912383 ° | 39.758788 ° -121.912383 ° | 11 Y |

View of the squirrel holes & bait station.

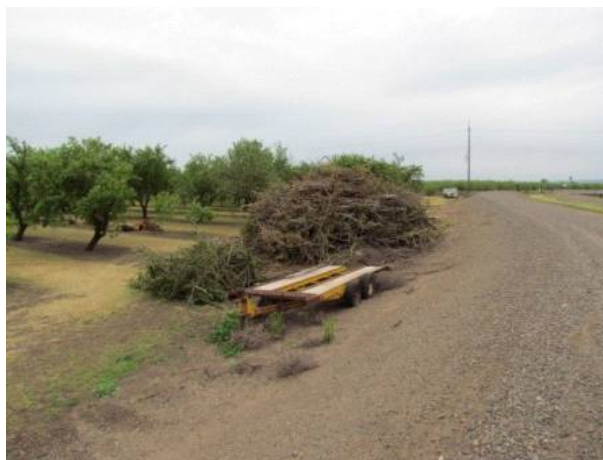
| Levee Mile Report Line | 6 |

| Waterway | | | | | | | Bank | Unit Miles | Inspection Start/End | Inspector |
|---|---|---|---|---|---|---|---|---|---|---|
| 6 | 3.00 | 3.00 | Earthen Levee | Encroachments | LS | M | Prunings | 39.759755 ° -121.911160 ° | 39.759755 ° -121.911160 ° | 1 Y |

View of the pruning pile along the L/S toe.

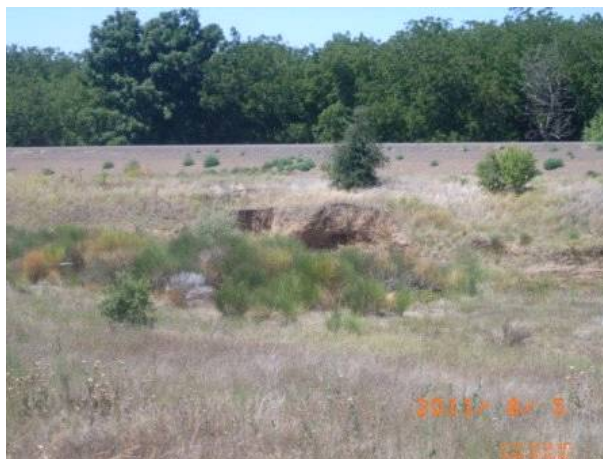
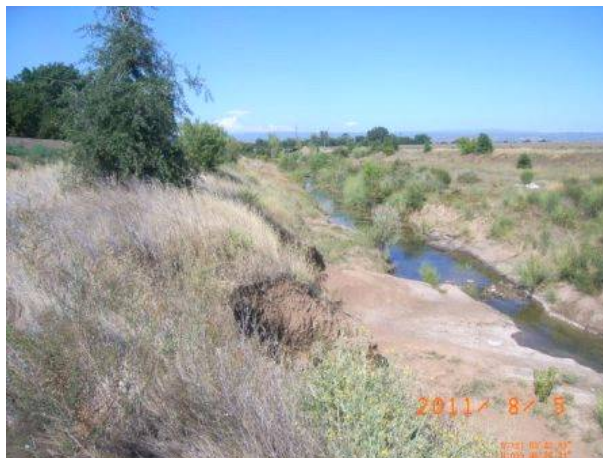
| Levee Mile Report Line | 12 |

| Waterway | | | | | | | Bank | Unit Miles | Inspection Start/End | Inspector |
|---|---|---|---|---|---|---|---|---|---|---|
| 12 | 4.22 | 4.22 | Supplemental | USACE Erosion Survey | WS | M | Inspector Comments: 2011: Two large erosion scallops at the toe from a rotational failure. Deep cracks along the slope indicate the potential for further failures. [2011 Site ID: MUD_4-4_R] | 39.773257 ° -121.895618 ° | 39.773969 ° -121.895078 ° | 13 Y |

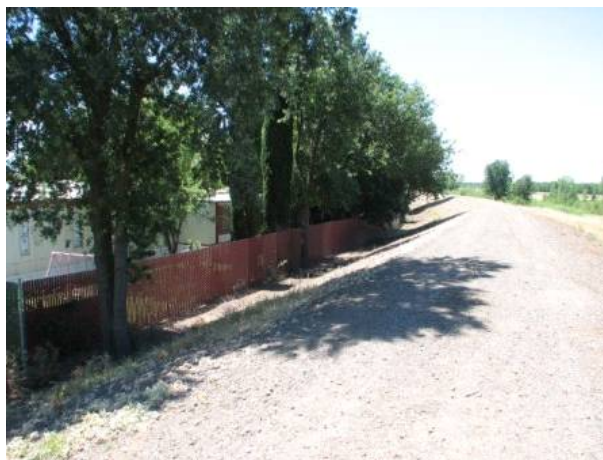
| Levee Mile Report Line | 1 |

| LMR No. | Levee Mile | | Category | Item | * Location | ** Rating | Action/Comment | GPS Latitude/Longitude | | Issue No. |
|---|---|---|---|---|---|---|--|---|---|---|
| 1 | 1.58 | 1.90 | Earthen Levee | Encroachments | LS | CO | Fences | 39.782773 ° -121.888178 ° | 39.778972 ° -121.891563 ° | 3 Y |

View of the fence along the landside toe of the levee.

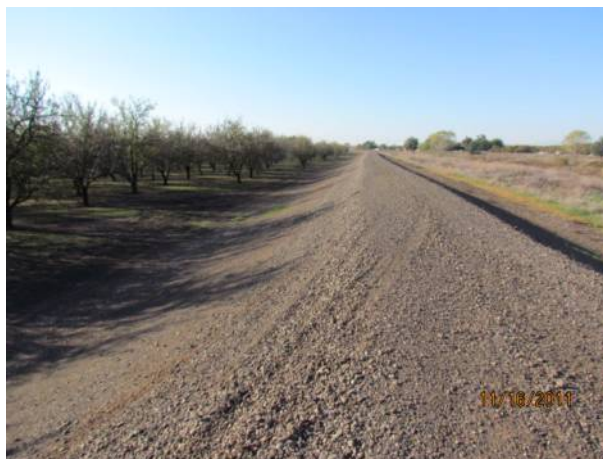
| Levee Mile Report Line | 2 |

| LMR No. | Levee Mile | | Category | Item | * Location | ** Rating | Action/Comment | GPS Latitude/Longitude | | Issue No. |
|---|---|---|---|---|---|---|--|---|---|---|
| 2 | 4.46 | 4.46 | Earthen Levee | Animal Control | LS | A | No rodents visible, but rodent burrows visible; need to backfill and compact or grout burrows. | 39.752465 ° -121.914632 ° | 39.752465 ° -121.914632 ° | 2 Y |

View of the repaired rodents borrows along L/S slope.

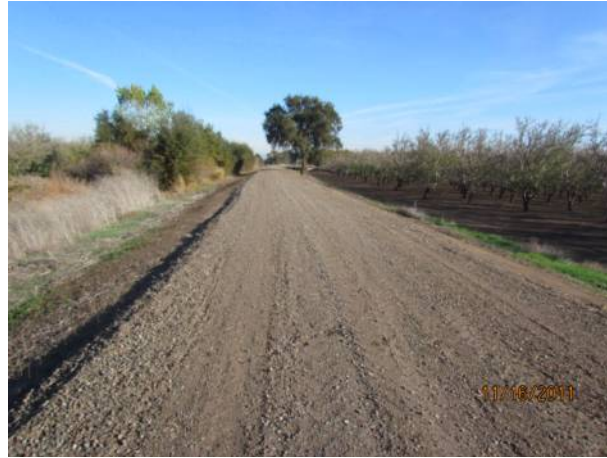
| Levee Mile Report Line | 1 |

| LMR No. | Levee Mile | | Category | Item | Location * | Rating ** | Action/Comment | GPS Latitude/Longitude | | Issue No. |
|---|---|---|---|---|---|---|---|---|---|---|
| 1 | 0.00 | 0.30 | Earthen Levee | Vegetation | LS | A | Remove the wild growth other than native grasses from the levee slopes. | 39.733263 ° -121.930042 ° | 39.733263 ° -121.930042 ° | 1 Y |

View of the new grass starting to grow.

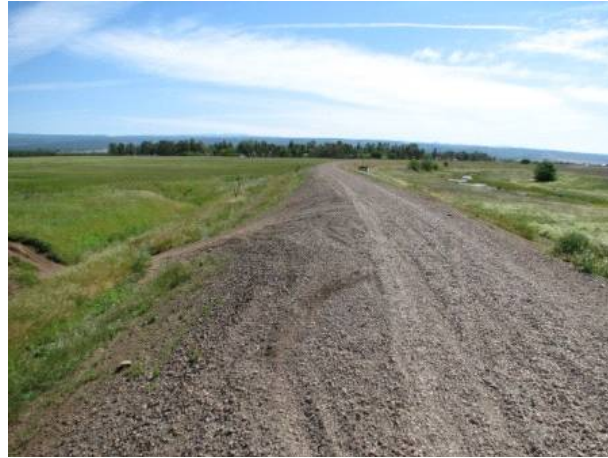
| LMR No. | Levee Mile | | Category | Item | Location * | Rating ** | Action/Comment | GPS Latitude/Longitude | | Issue No. Photo |
|---|---|---|---|---|---|---|--|---|---|---|
| 1 | 0.06 | 0.06 | Earthen Levee | Slope Stability | WS | M | Repair the levee slope damaged by vehicle traffic and prevent access where possible. | 39.786068 ° -121.881828 ° | 39.786068 ° -121.881828 ° | 3 Y |

View of the motorcycle erosion on the landside slope of the levee.

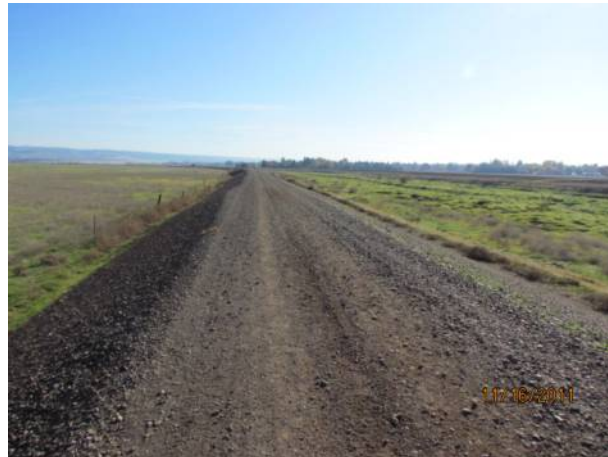
| Levee Mile Report Line | 2 |

View of the levee with new grass starting to grow.

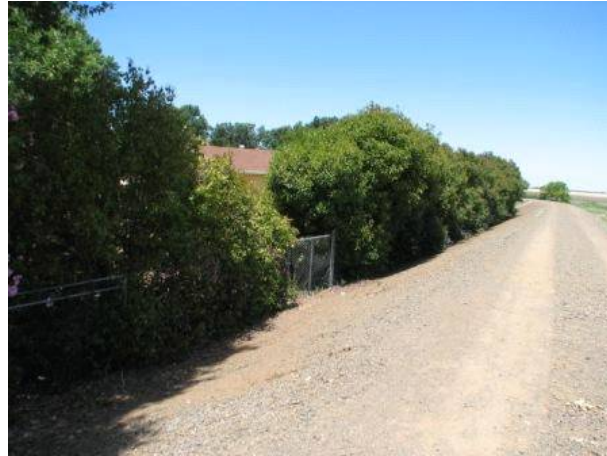
View of the fence and trees along the landside toe of the levee.

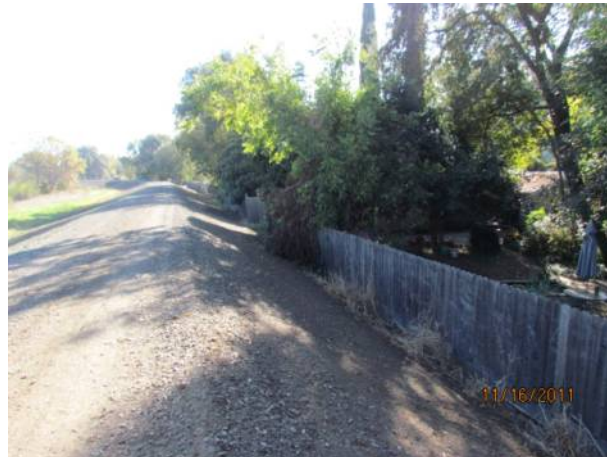
| Levee Mile Report Line | 2 |

View of the fence along the l/s toe.

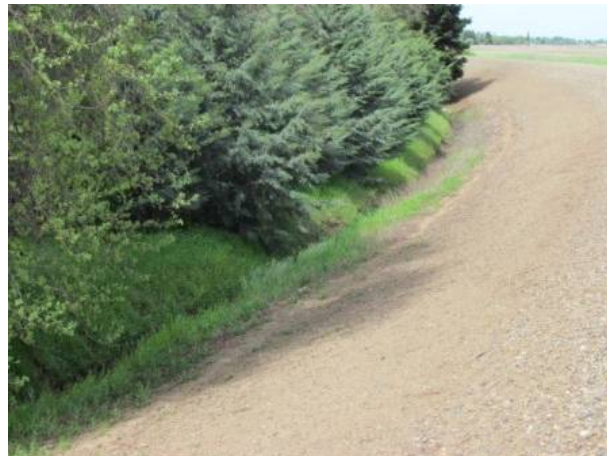
| Levee Mile Report Line | 3 |

View of AG ditch at the L/S toe.

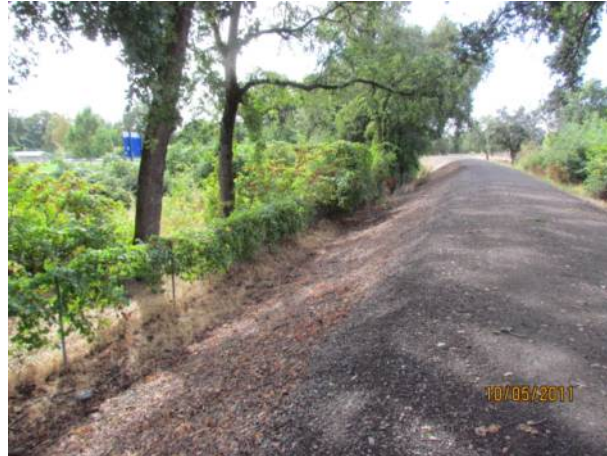
View of the L/S slope.

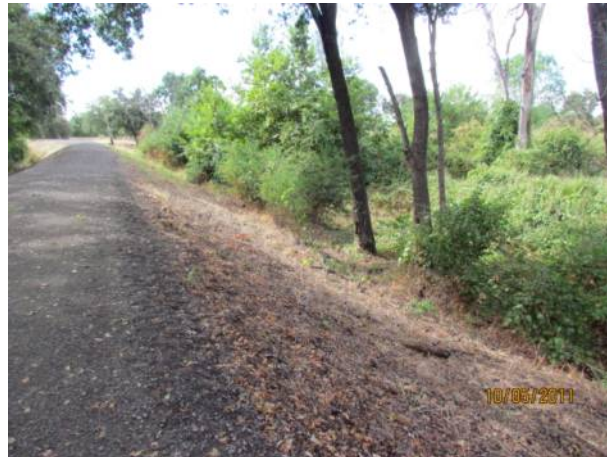
| Levee Mile Report Line | 4 |

View of the W/S slope.
